How safe are our rural structures? Lessons from the 2011 Sikkim Earthquake

Sandeep Tambe*, Rajesh Kumar, M. L. Arrawatia and Anil K. Ganeriwala

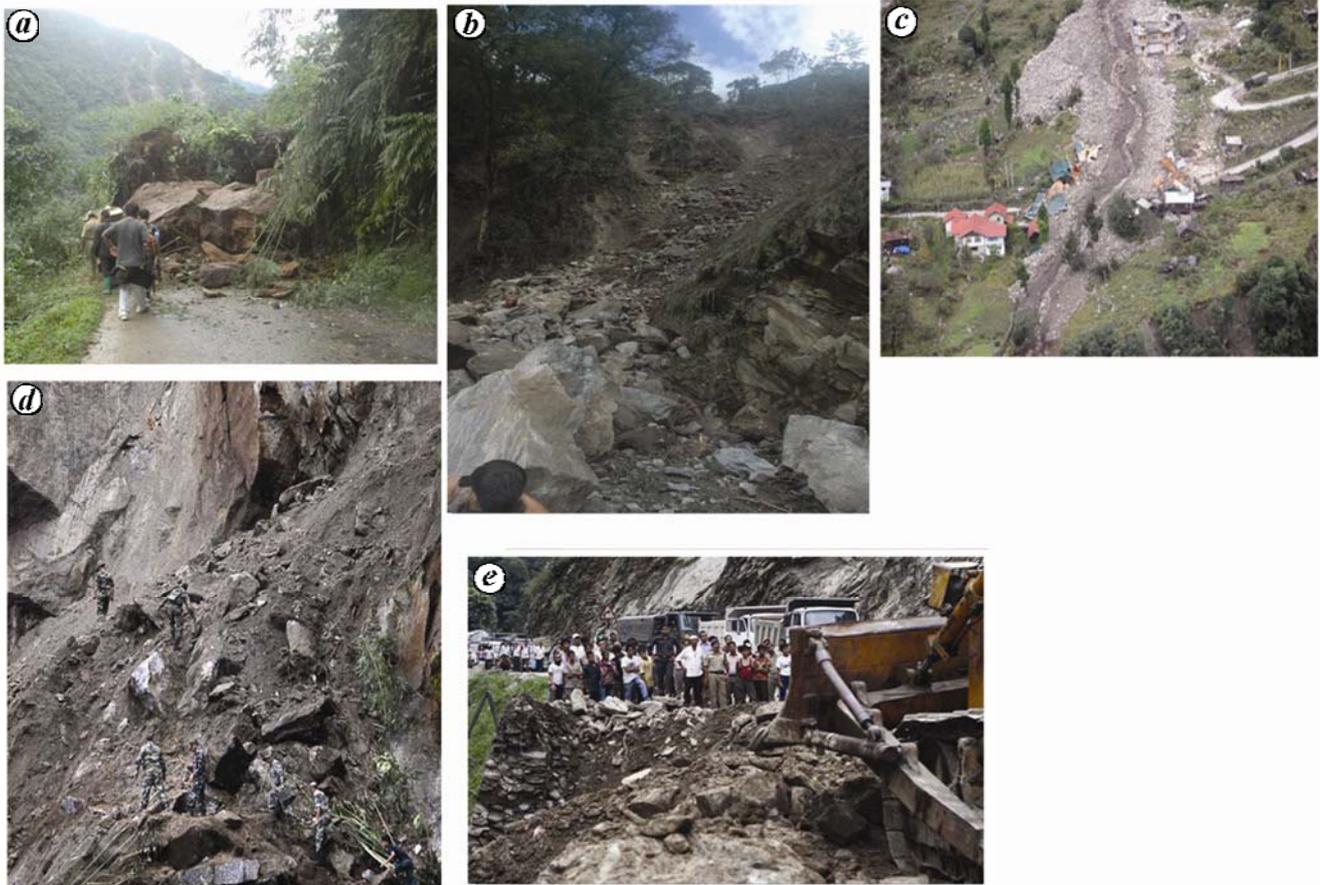
Figure 1. Weak geology, fragile ecology and heavy rainfall all combined to amplify the impact of the earthquake resulting in thousands of natural calamities in the form of landslides and slips, boulder falls and flash floods and causing colossal collateral damage. *a*, Boulder falls. *b*, Landslides. *c*, Flash flood in Lachung, North Sikkim. *d*, Cliff caves in on the national highway. *e*, Landslides block the national highway.

landslides, boulder falls and flash floods, thereby magnifying the damage to human life and property several times (Figure 1). Dzongu region in North District which was the closest to the epicentre was the worst hit (Figure 2).

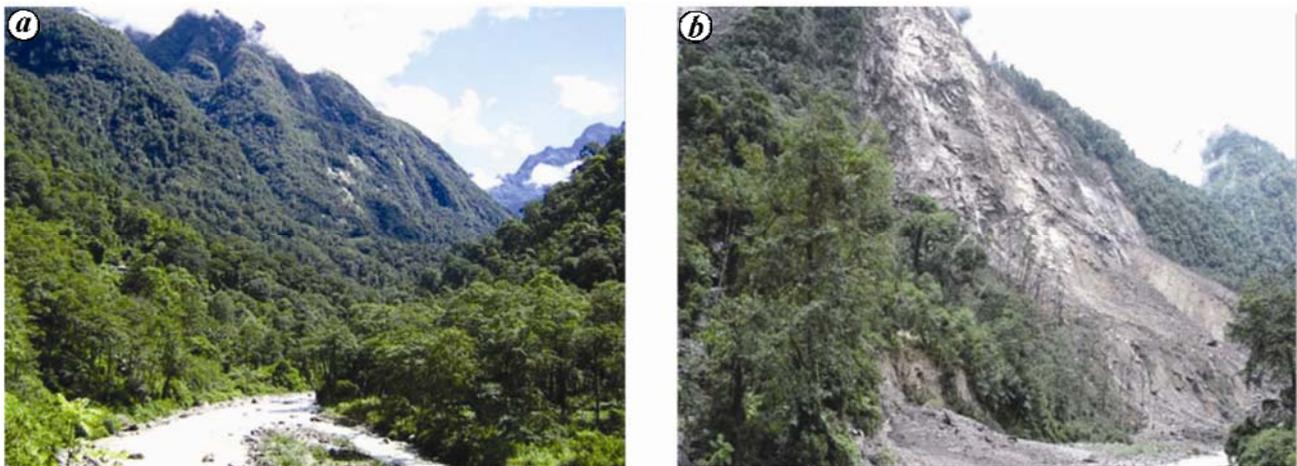
Figure 2. Bay village located in the heart of the Dzongu Tribal Reserve, in the highest district in the country – North Sikkim. The whole village was severely impacted by massive landslides following the earthquake. *a*, Before the earthquake; *b*, After the earthquake.

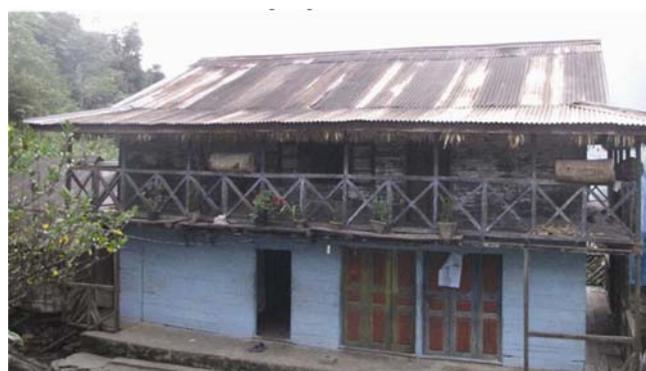
Figure 3. Traditional houses are typically two-storeyed, with framed structure made from woven bamboo or wood having a light CGI sheet roof.

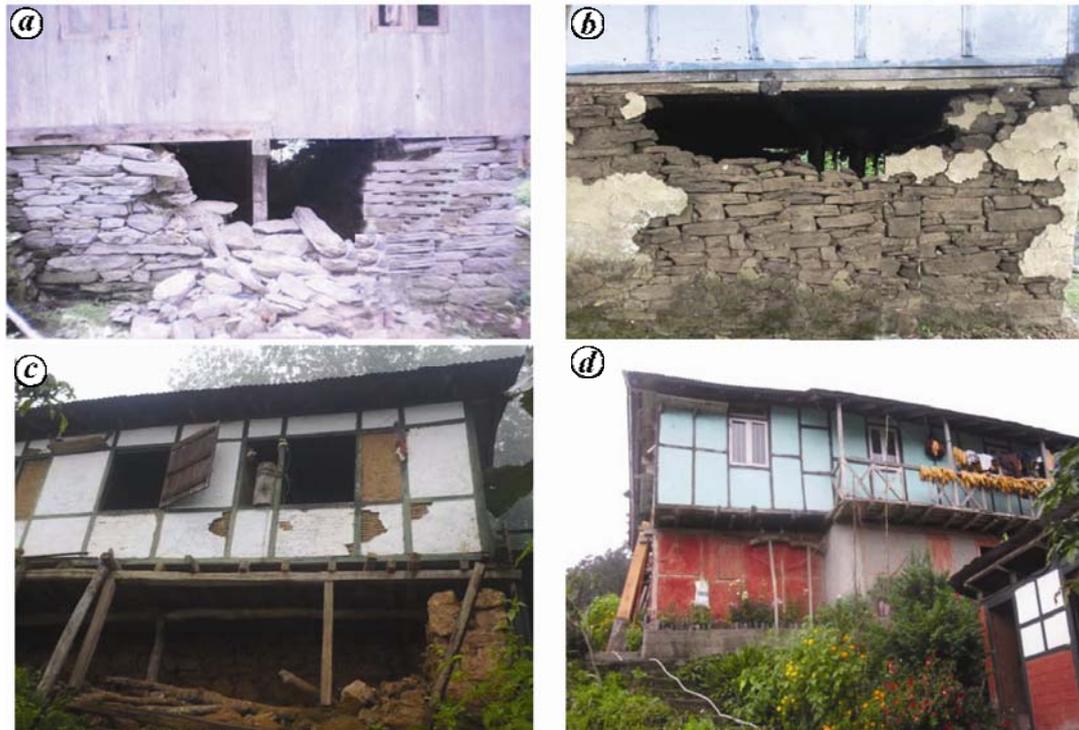
- Failure of the stone masonry walls that bulged or collapsed (Figure 4 *a* and *b*). These load-bearing walls are poor in carrying horizontal earthquake inertia forces along the direction of their thickness owing to the use of multiple irregular stones in the cross-section and absence of 'through stones' (Figure 5).
- Houses were built near the stone masonry retaining wall where filling had been done. The shaking of the

Figure 4. Partially collapsed load-bearing stone masonry wall supporting light-weight bamboo/wooden house with CGI sheet roof. *a, b*, House with (*a*) wooden walls and (*b*) with bamboo and wooden frame. *c, d*, Retrofitting with wooden posts.

state had suffered various degrees of damage, there were only a few deaths due to these houses, highlighting their inherent earthquake-safe character. While the superstructure of these wooden framed houses with bamboo walling and a light iron-sheet roof was found to be mostly intact, the stone masonry load-bearing walls laid on mud mortar and not having reinforcement suffered maximum damage. Though these stone walls were damaged or partially collapsed, the upper storey made of ekra with wooden frame and CGI sloping roof had tilted and can be retrofitted locally and made liveable again (Figure 4 *c* and *d*).

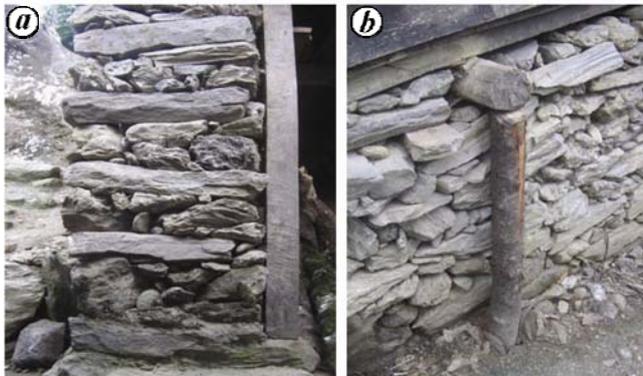
Figure 5. Cross-section of the stone masonry wall with mud mortar. *a*, 'Through stones' in stone masonry wall are vital in preventing the wall from collapsing. *b*, Bulging is more prominent in stone masonry walls because of the absence of 'through stones' and needs to be retrofitted with wooden posts.

(instead of dressed ones). Use of ‘through stones’ in stone masonry walls is critical to prevent the wall from collapsing (Figure 5). The wall thickness should not exceed 0.45 m. Irregular stones should not be used; instead they should be dressed using chisel and hammer. Cement-sand mortar (1 : 6 or richer) should be used instead of mud mortar. The unsupported length of walls between cross-walls should be limited to 5 m; for longer walls, buttresses should be provided at spacing not more than 4 m. The height of each storey should not exceed 3 m (ref. 9). In order to facilitate better know-how in the making of new traditional houses with earthquake-resistant design, mass practical trainings of the local masons and orientation of the local community are needed. These along with illus-

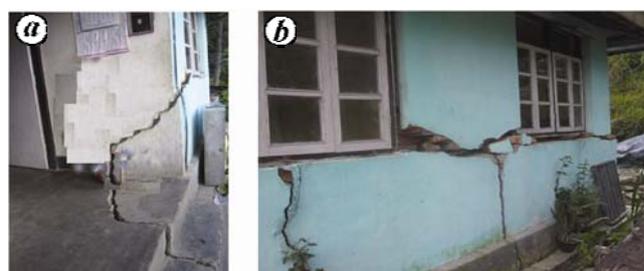
These houses not very common in rural areas, were typically single-storeyed with brick masonry/hollow block and cement mortar walling and light weight CGI roofs. Generally brick infill showed better performance than stone masonry with mud mortar. However, hollow concrete block walling suffered severe damage. A few of these houses showed subsidence wherever built near the stone masonry retaining wall, where filling had taken place (Figure 6). Due to the shaking the filled earth shifted down, thus damaging the foundation of the house. Also these houses did not have reinforcement in the form of reinforced concrete (RC) columns, plinth beam or lintel band.

Figure 6. Damage to brick masonry houses with CGI sheet roofs. *a*, Subsidence due to sinking of the fill part of the foundation. *b*, Cracks extending up to the plinth, indicating the need for plinth beam to hold the structure together.

trated booklets in the local language indicating the improvements will go a long way in ensuring that these principles become a standard practice in traditional house construction in the rural areas. Brick masonry structures need to be reinforced with plinth-level beam and lintel band. Care should be taken so that they are not built near the retaining wall where filling has been done. Traditional buildings like historical monasteries need to be retrofitted by reinforcing the tall stone masonry walls by providing RC-frame, lintel bands, buttress walls, etc.

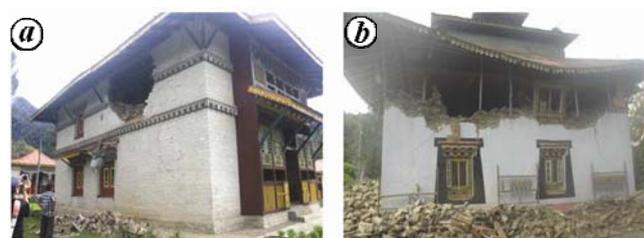
More than 50 heritage buildings, comprising mostly of several centuries old Buddhist monasteries were severely impacted. These buildings are typically made from stone masonry with dressed stones and cement mortar. The walls are often very wide (often 0.6 m) and two storeys tall with a CGI sheet roof. In most cases, the stone masonry wall collapsed resulting in damage to the ancient relics, historical artefacts, religious manuscripts, and wall and ceiling frescoes (Figure 7).

Figure 7. Extensive damage to stone masonry walls of tall heritage structures. *a*, Dubdi monastery, Yuksam, West Sikkim. *b*, Ringhim monastery, Mangan, North Sikkim.

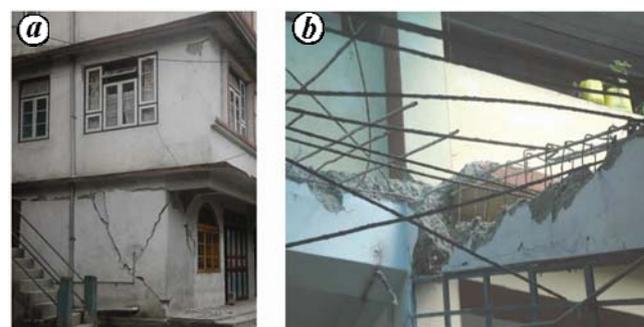
Private houses with RC-frame structure with brick masonry infill and CGI sheet roof performed well, showing non-structural damage mostly in the form of cracks in the infill walls (Figure 8a). Severe damage took place in buildings where the new owner had carried out vertical extension of several storeys without taking into consideration the structural strength of the earlier constructed house. Multi-storeyed, RC-frame, engineered buildings like schools, government offices, etc. were severely damaged (Figure 8b). These buildings have suffered from corrosion of reinforcement bars, from damage to columns and beams, failure of gable wall, severe cracking in infill walls and separation between RC-frame and infill.

Figure 8. Damage to RC-frame buildings. *a*, Non-structural damage in the form of diagonal cracks in the infill walls and separation from RC frame. *b*, Severe structural damage to multi-storeyed, engineered school building.

In RC construction, good construction practices need to be propagated, and the building and seismic codes need to be enforced (IS:1893 2002; IS:13920 1993; IS:4326 1993)^{7,10}. Light CGI sheet roofs should be preferred over RC slabs, lintel band should be introduced and infill walls should be tied to the RC-frame. Building and seismic codes should be strictly enforced, and material and workmanship quality improved. Another urgent requirement is training and supply of booklets to government as well as private engineers and to the local people on how to incorporate simple techniques in buildings to make them earthquake-resistant. Compliance to these codes can be improved by making building insurance compulsory for all new constructions. The insurance companies will ensure that all the building safeguards are incorporated. This earthquake should serve as a wake-up call to different stakeholders (architects, engineers, masons, contractors, material manufacturers, public, etc.) to safeguard against future earthquakes.
