# How safe are our rural structures? Lessons from the 2011 Sikkim Earthquake

**Keywords:** Damage assessment, earthquakes, preparedness, rural structures.

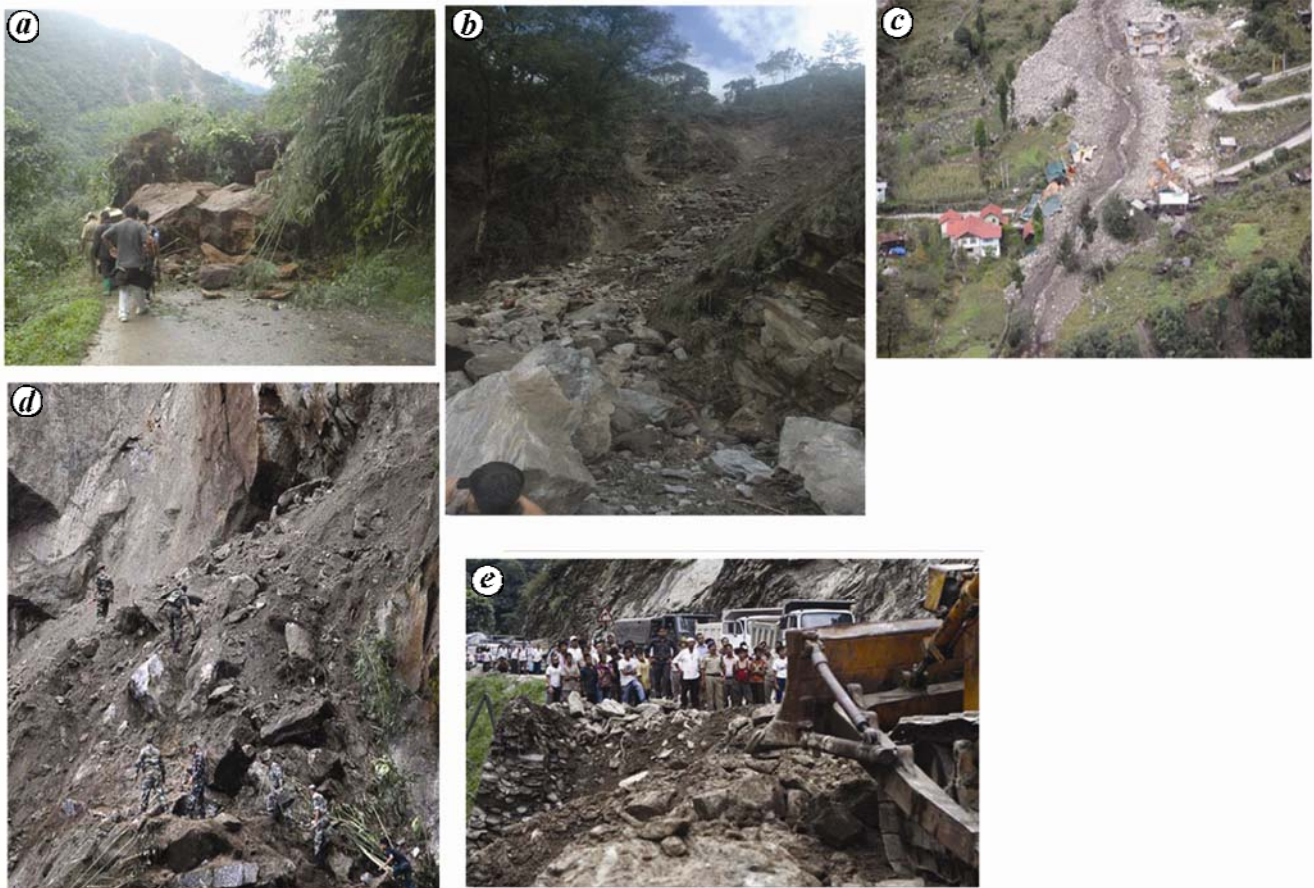
**Figure 1.** Weak geology, fragile ecology and heavy rainfall all combined to amplify the impact of the earthquake resulting in thousands of natural calamities in the form of landslides and slips, boulder falls and flash floods and causing colossal collateral damage. *a*, Boulder falls. *b*, Landslides. *c*, Flash flood in Lachung, North Sikkim. *d*, Cliff caves in on the national highway. *e*, Landslides block the national highway.

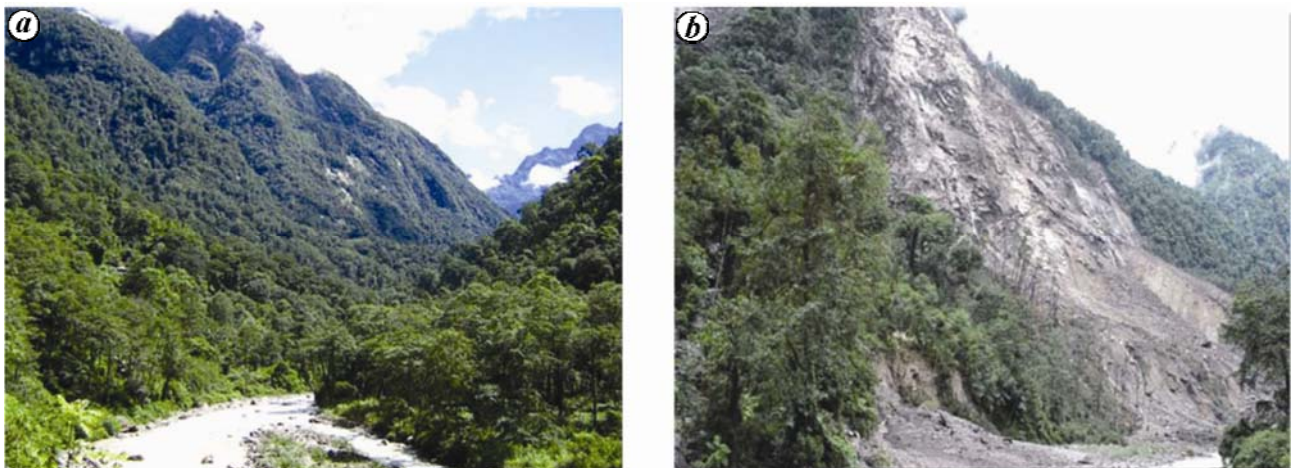
**Figure 2.** Bay village located in the heart of the Dzongu Tribal Reserve, in the highest district in the country – North Sikkim. The whole village was severely impacted by massive landslides following the earthquake. *a*, Before the earthquake; *b*, After the earthquake.

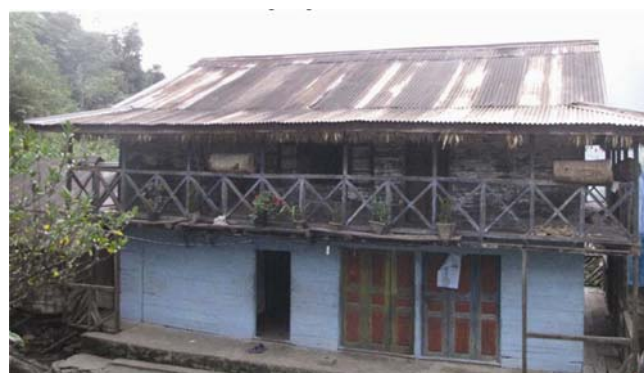
**Figure 3.** Traditional houses are typically two-storeyed, with framed structure made from woven bamboo or wood having a light CGI sheet roof.

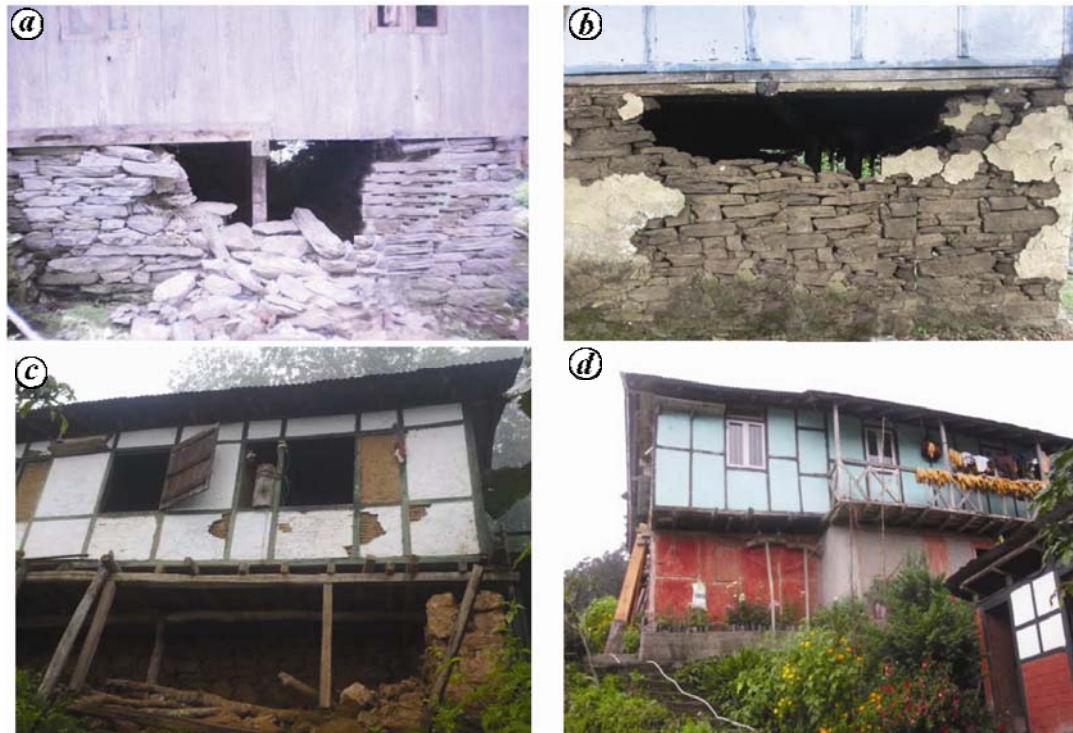
- Failure of the stone masonry walls that bulged or collapsed (Figure 4 *a* and *b*). These load-bearing walls are poor in carrying horizontal earthquake inertia forces along the direction of their thickness owing to the use of multiple irregular stones in the cross-section and absence of 'through stones' (Figure 5).
- Houses were built near the stone masonry retaining wall where filling had been done. The shaking of the

**Figure 4.** Partially collapsed load-bearing stone masonry wall supporting light-weight bamboo/wooden house with CGI sheet roof. *a, b*, House with (*a*) wooden walls and (*b*) with bamboo and wooden frame. *c, d*, Retrofitting with wooden posts.

state had suffered various degrees of damage, there were only a few deaths due to these houses, highlighting their inherent earthquake-safe character. While the superstructure of these wooden framed houses with bamboo walling and a light iron-sheet roof was found to be mostly intact, the stone masonry load-bearing walls laid on mud mortar and not having reinforcement suffered maximum damage. Though these stone walls were damaged or partially collapsed, the upper storey made of ekra with wooden frame and CGI sloping roof had tilted and can be retrofitted locally and made liveable again (Figure 4 *c* and *d*).

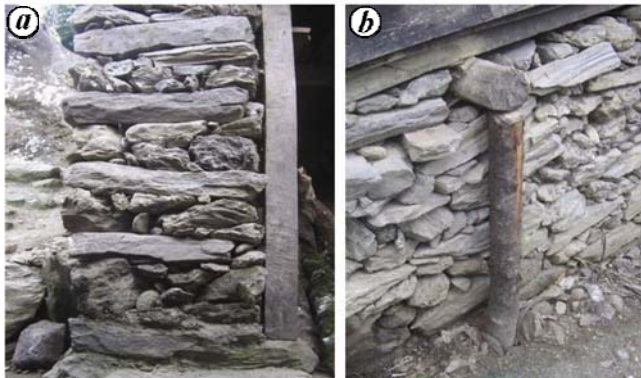
**Figure 5.** Cross-section of the stone masonry wall with mud mortar. *a*, 'Through stones' in stone masonry wall are vital in preventing the wall from collapsing. *b*, Bulging is more prominent in stone masonry walls because of the absence of 'through stones' and needs to be retrofitted with wooden posts.

(instead of dressed ones). Use of ‘through stones’ in stone masonry walls is critical to prevent the wall from collapsing (Figure 5). The wall thickness should not exceed 0.45 m. Irregular stones should not be used; instead they should be dressed using chisel and hammer. Cement-sand mortar (1 : 6 or richer) should be used instead of mud mortar. The unsupported length of walls between cross-walls should be limited to 5 m; for longer walls, buttresses should be provided at spacing not more than 4 m. The height of each storey should not exceed 3 m (ref. 9). In order to facilitate better know-how in the making of new traditional houses with earthquake-resistant design, mass practical trainings of the local masons and orientation of the local community are needed. These along with illus-

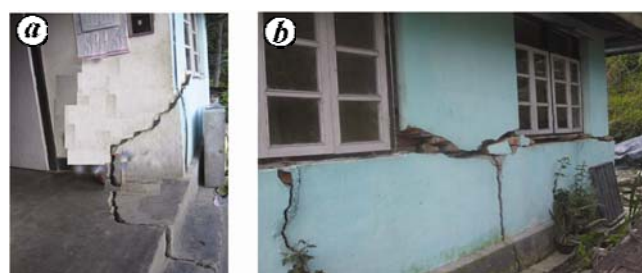
These houses not very common in rural areas, were typically single-storeyed with brick masonry/hollow block and cement mortar walling and light weight CGI roofs. Generally brick infill showed better performance than stone masonry with mud mortar. However, hollow concrete block walling suffered severe damage. A few of these houses showed subsidence wherever built near the stone masonry retaining wall, where filling had taken place (Figure 6). Due to the shaking the filled earth shifted down, thus damaging the foundation of the house. Also these houses did not have reinforcement in the form of reinforced concrete (RC) columns, plinth beam or lintel band.

**Figure 6.** Damage to brick masonry houses with CGI sheet roofs. *a*, Subsidence due to sinking of the fill part of the foundation. *b*, Cracks extending up to the plinth, indicating the need for plinth beam to hold the structure together.

trated booklets in the local language indicating the improvements will go a long way in ensuring that these principles become a standard practice in traditional house construction in the rural areas. Brick masonry structures need to be reinforced with plinth-level beam and lintel band. Care should be taken so that they are not built near the retaining wall where filling has been done. Traditional buildings like historical monasteries need to be retrofitted by reinforcing the tall stone masonry walls by providing RC-frame, lintel bands, buttress walls, etc.

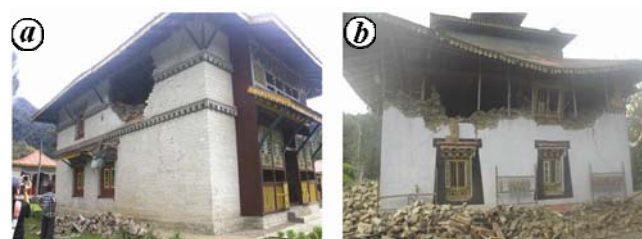
More than 50 heritage buildings, comprising mostly of several centuries old Buddhist monasteries were severely impacted. These buildings are typically made from stone masonry with dressed stones and cement mortar. The walls are often very wide (often 0.6 m) and two storeys tall with a CGI sheet roof. In most cases, the stone masonry wall collapsed resulting in damage to the ancient relics, historical artefacts, religious manuscripts, and wall and ceiling frescoes (Figure 7).

**Figure 7.** Extensive damage to stone masonry walls of tall heritage structures. *a*, Dubdi monastery, Yuksam, West Sikkim. *b*, Ringhim monastery, Mangan, North Sikkim.

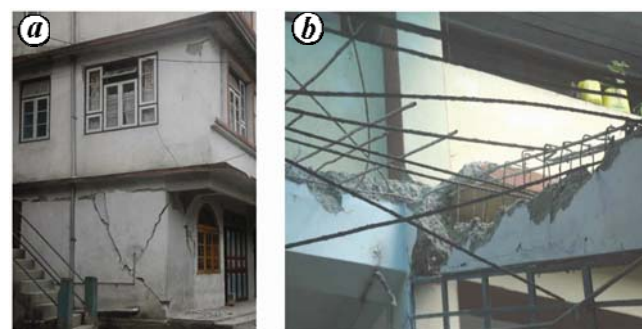
Private houses with RC-frame structure with brick masonry infill and CGI sheet roof performed well, showing non-structural damage mostly in the form of cracks in the infill walls (Figure 8a). Severe damage took place in buildings where the new owner had carried out vertical extension of several storeys without taking into consideration the structural strength of the earlier constructed house. Multi-storeyed, RC-frame, engineered buildings like schools, government offices, etc. were severely damaged (Figure 8b). These buildings have suffered from corrosion of reinforcement bars, from damage to columns and beams, failure of gable wall, severe cracking in infill walls and separation between RC-frame and infill.

**Figure 8.** Damage to RC-frame buildings. *a*, Non-structural damage in the form of diagonal cracks in the infill walls and separation from RC frame. *b*, Severe structural damage to multi-storeyed, engineered school building.

In RC construction, good construction practices need to be propagated, and the building and seismic codes need to be enforced (IS:1893 2002; IS:13920 1993; IS:4326 1993)<sup>7,10</sup>. Light CGI sheet roofs should be preferred over RC slabs, lintel band should be introduced and infill walls should be tied to the RC-frame. Building and seismic codes should be strictly enforced, and material and workmanship quality improved. Another urgent requirement is training and supply of booklets to government as well as private engineers and to the local people on how to incorporate simple techniques in buildings to make them earthquake-resistant. Compliance to these codes can be improved by making building insurance compulsory for all new constructions. The insurance companies will ensure that all the building safeguards are incorporated. This earthquake should serve as a wake-up call to different stakeholders (architects, engineers, masons, contractors, material manufacturers, public, etc.) to safeguard against future earthquakes.
